Phase One Inspection Report

Sea Dunes Condominium Association

November 7, 2023

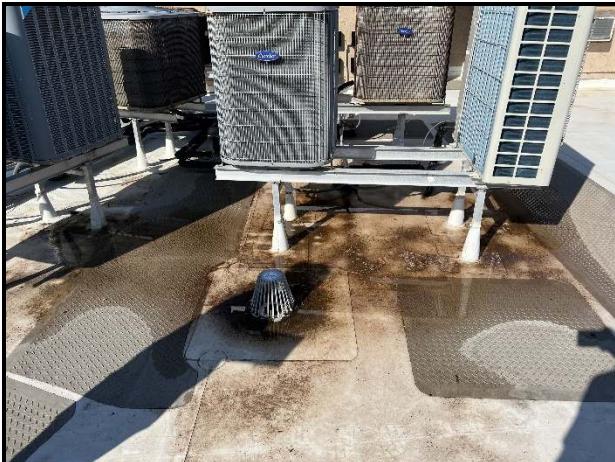
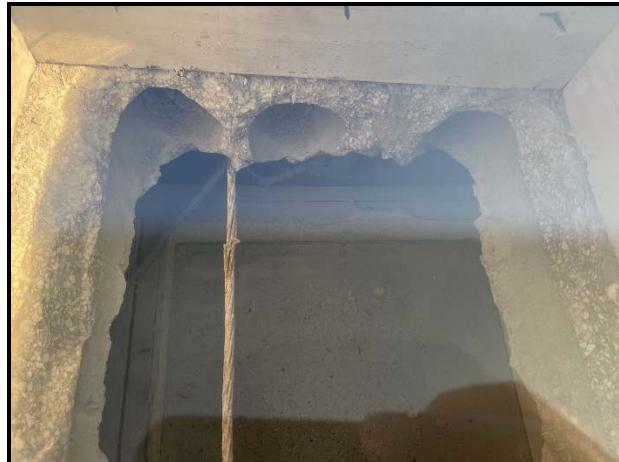
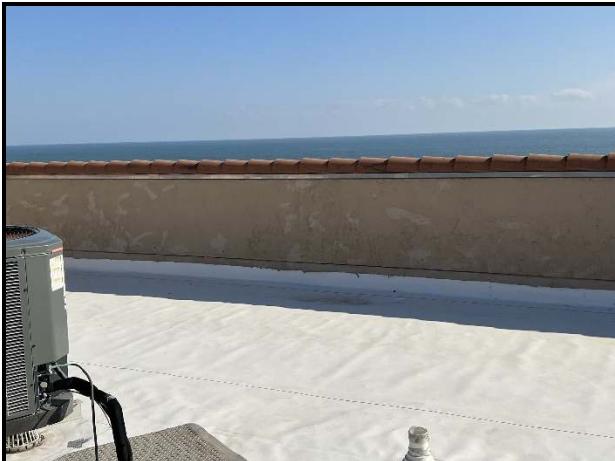
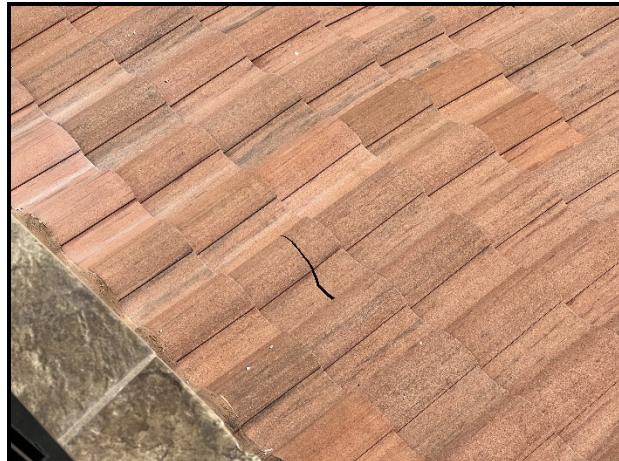
The main building has a TPO roof with areas of tile roof while the porte cochere has a modified bitumen roof. Sea Dunes roofs have skylights installed. The hollow core panels are cut, including the tendons for the skylights. Skylights appear to be closed off from the underside. Ponding water observed in numerous locations. Isolated broken tile was observed as well.

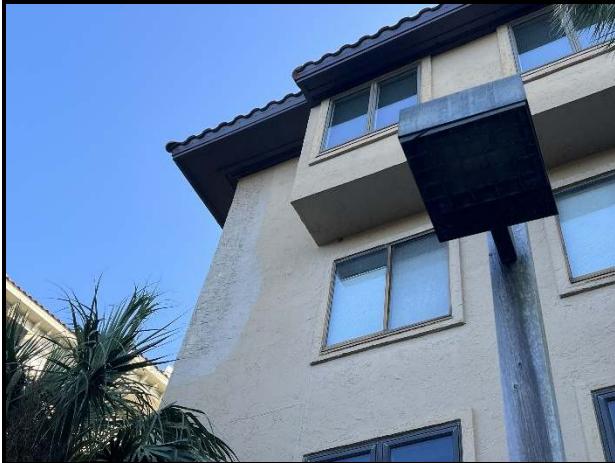
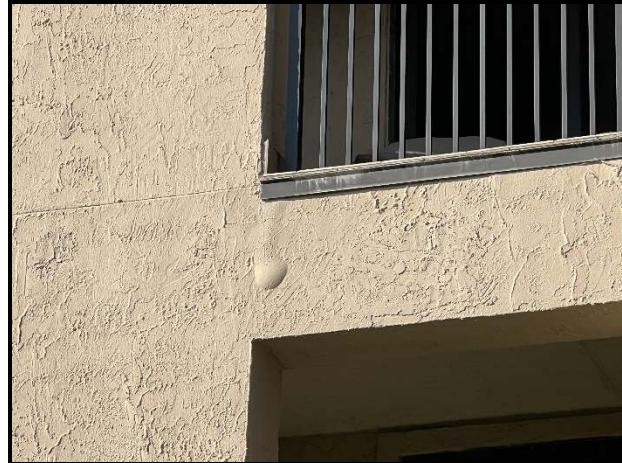
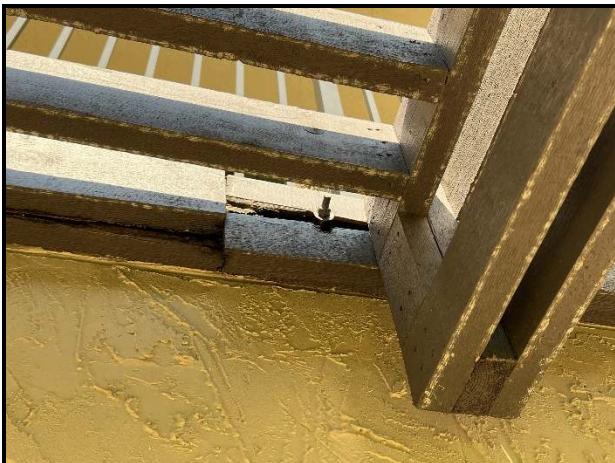
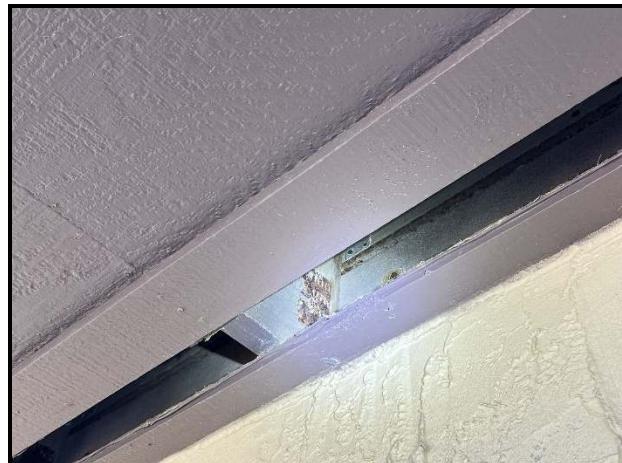
Stucco cracks were observed in previous repair fields. Rust spots were visible as well as efflorescence and leaching of wall on the east side 6th floor. 4th floor northwest side has a crack/spall. Wood framed pergolas have deteriorating and split members. Soffits are damaged, allowing for a visual inspection. Metal framing was found to be corroding.

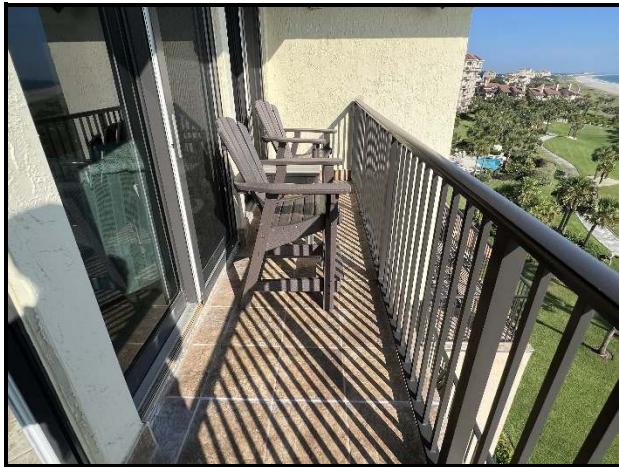
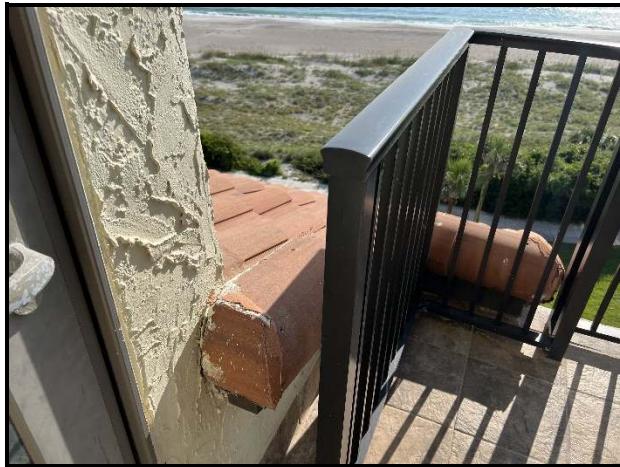
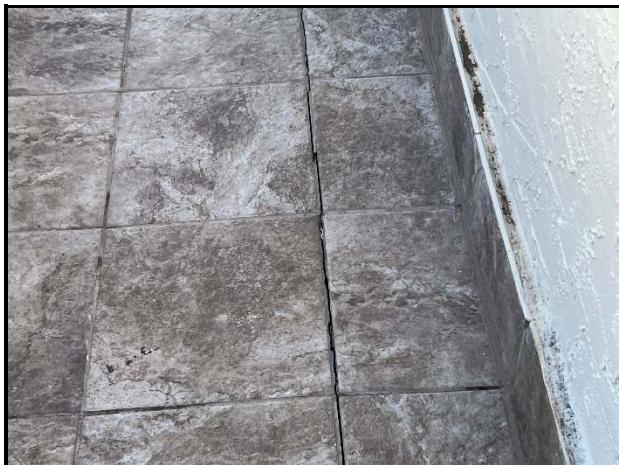
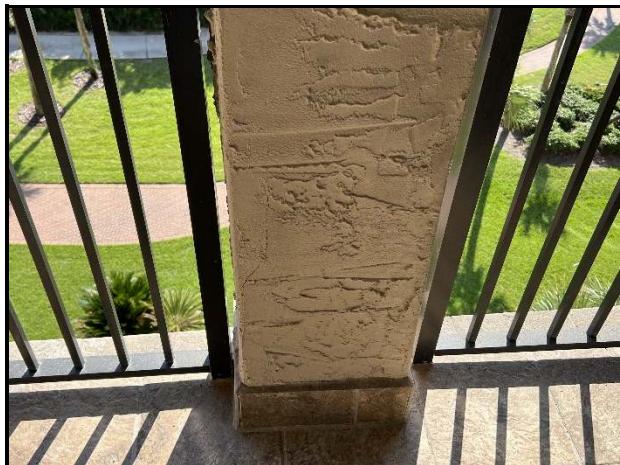
Additional Comments:
Efflorescence and leaching was observed from a beam. Select balconies have rails that are terminated short of the wall, allowing a person access to the sloped roofs. Isolated balconies have broken or cracked tile.

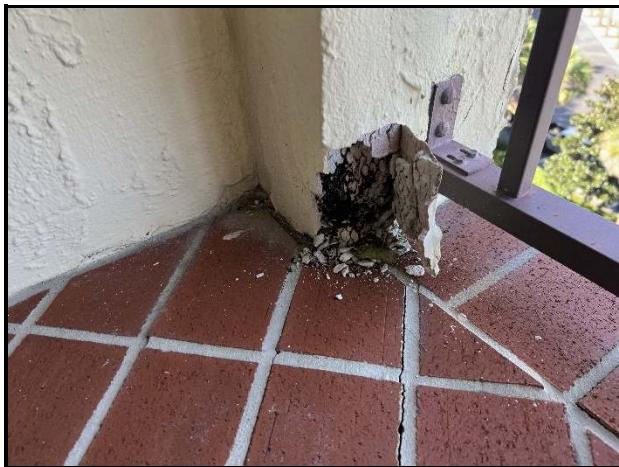
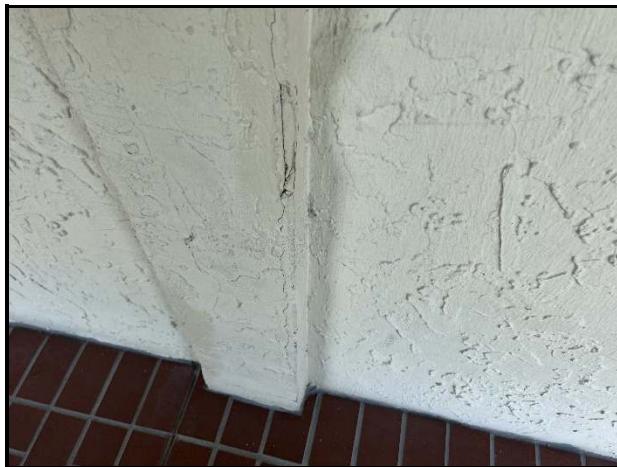
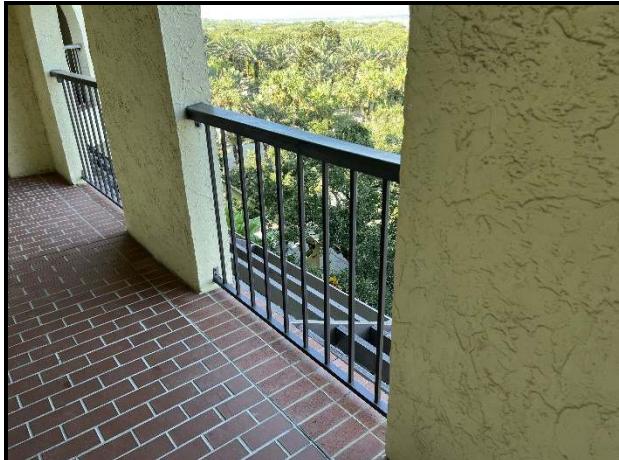
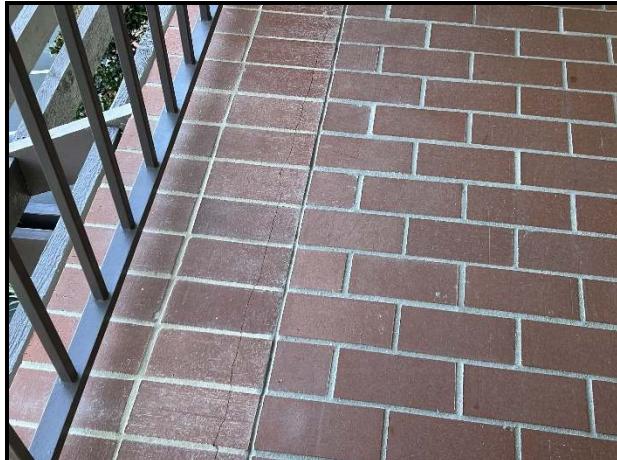
Rebar Corrosion:		None Observed	
Surface Condition (Select all that apply): <input type="checkbox"/> Waterproofing System <input type="checkbox"/> Uncoated Concrete <input checked="" type="checkbox"/> Tile <input type="checkbox"/> Carpet <input type="checkbox"/> Paint Only <input type="checkbox"/> Wood <input type="checkbox"/> Other:			
Guardrail Inspection: Rail Condition: Fair Code Compliant: No Rail Construction (Select all that apply): <input type="checkbox"/> Vinyl <input type="checkbox"/> Wood <input type="checkbox"/> Aluminum <input checked="" type="checkbox"/> Steel Mounting Type: Surface Type of Hardware: Ferrous Metal			
Additional Comments: Impact damage found on the breezeways. Delaminated and cracked tile was found in numerous locations. Rail picket spacing is 6 inches.

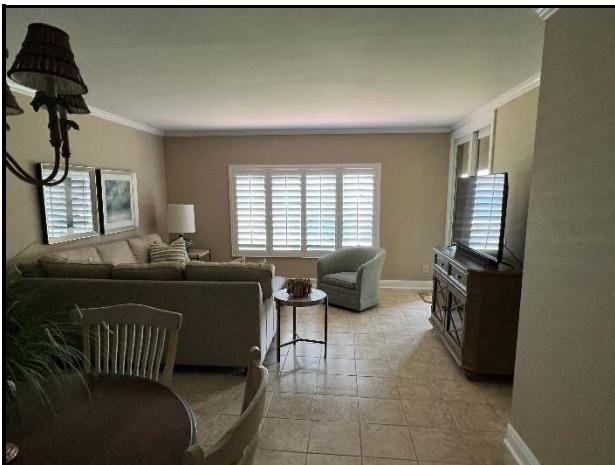
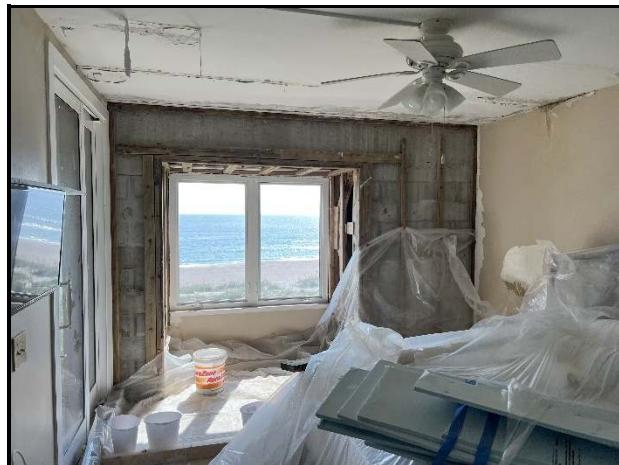
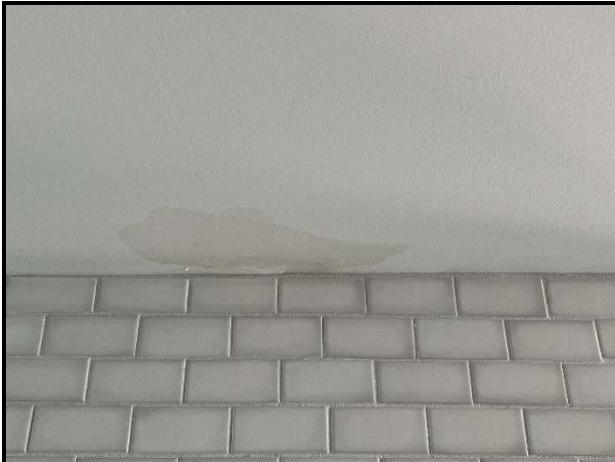
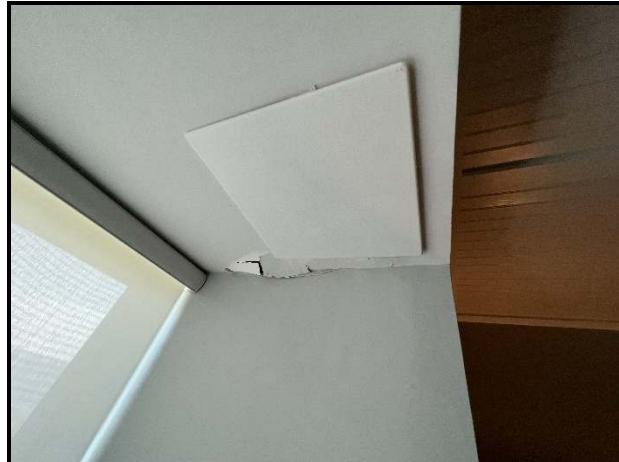
Concrete Cracks Present:	None Observed	Severity of Cracks:	Not Applicable
Location of Cracks (Select all that apply):			
<input type="checkbox"/> Column	<input type="checkbox"/> Wall	<input type="checkbox"/> Slab	<input type="checkbox"/> Beam
Rebar Corrosion:		None Observed	
Wood Inspection:		<input type="checkbox"/> Not Applicable	
Wood Deterioration:	None Observed	Severity of Deterioration:	Not Applicable
Additional Comments:			
One unit had staining on ceiling from a previous roof leak. Two units are under construction/renovation from water intrusion damage.
